EXHIBIT 7

July 26, 2019

As you requested, this is a letter report on the vegetation management field inspections ("VM inspections") the Monitor team is conducting pursuant to the Court's April 3, 2019 Order ("April 3 Order"). This submission includes: (1) background information on the VM inspections; (2) an explanation of the VM inspections process; (3) the Monitor team's preliminary observations; (4) PG&E's feedback based on the Monitor team's preliminary findings; (5) the Monitor team's preliminary suggestions to PG&E, as shared with the Company on July 17, 2019; and (6) concluding thoughts.

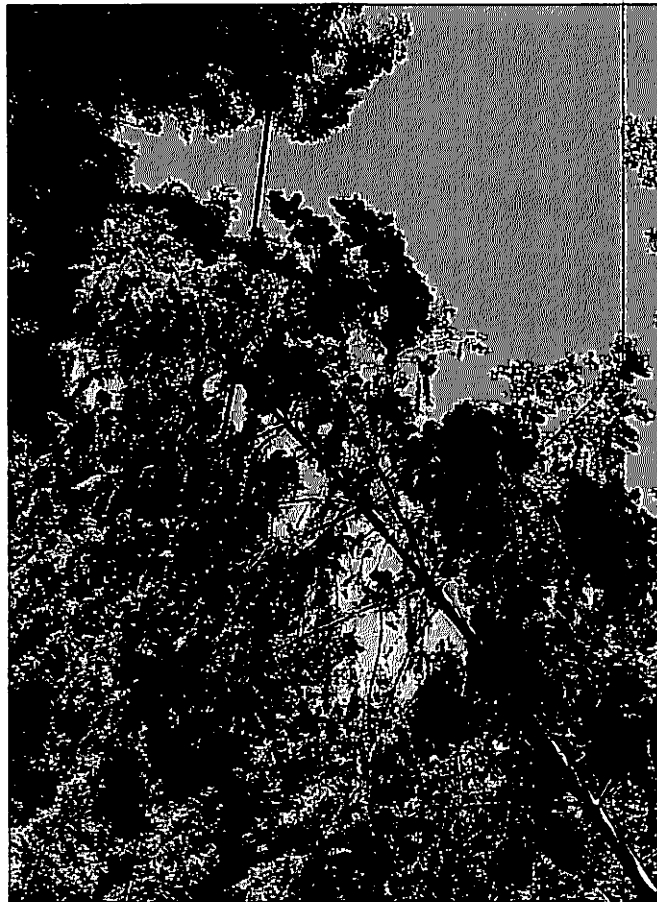
Second, on July 11, 2019, the Monitor team informed PG&E of a tree that was in contact with a primary conductor near the driveway of a private residence (see Figure 10 below). The Monitor team stayed in the area until a PG&E-dispatched pre-inspector arrived. The pre-inspector remained on the scene until a tree crew arrived to address the issue later that day.

Figure 10: Tree found by Monitor team on July 11, 2019 that was in contact with a primary conductor.

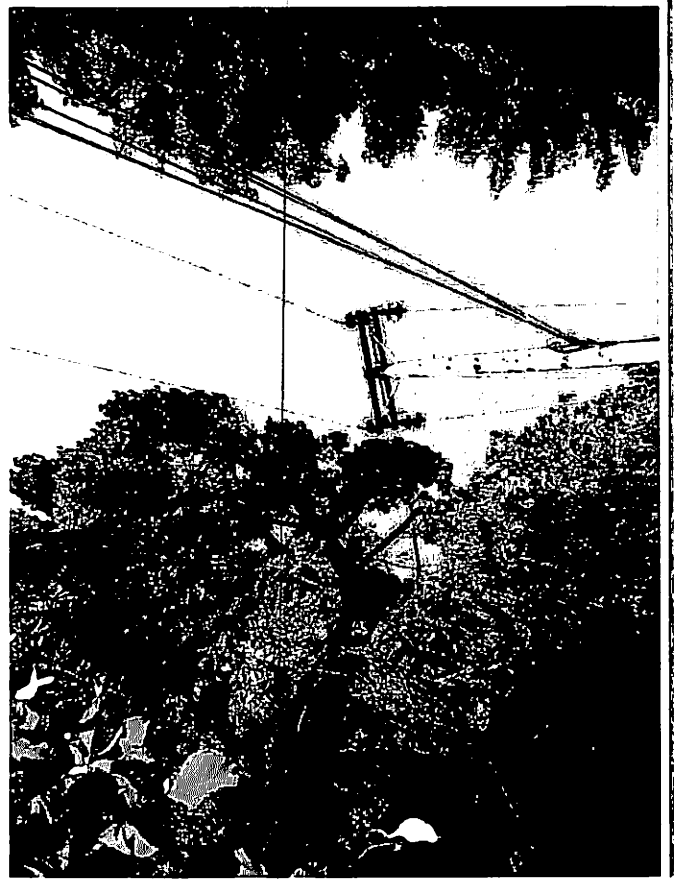
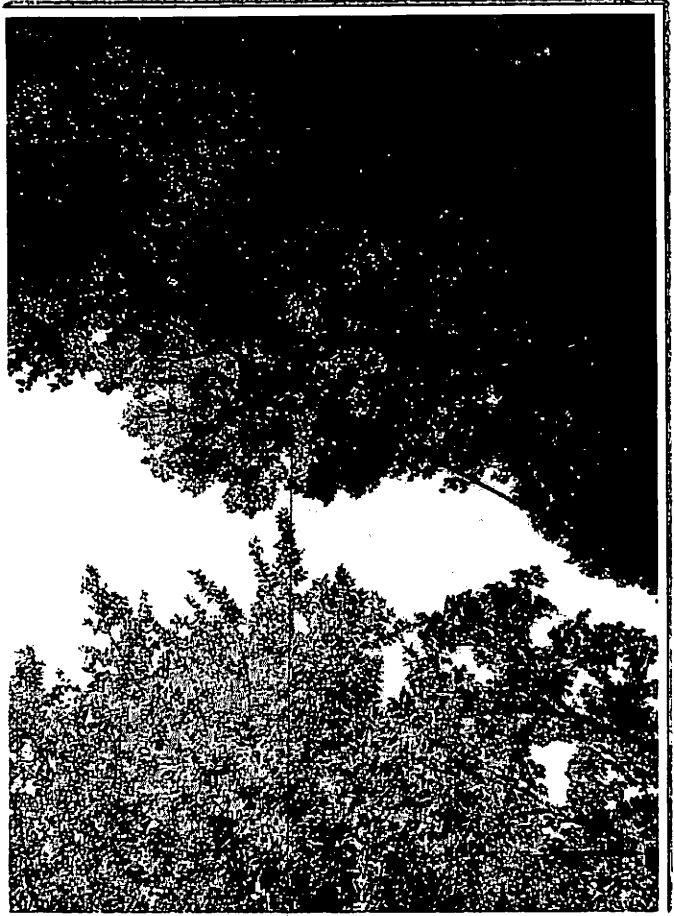
- The Monitor team noted multiple instances where overhangs were not completely cleared (*example photos below*).
- Relatedly, the Monitor team observed that some trees were pruned to clear overhanging vegetation up to a certain height, but the highest portion of the tree was not pruned.

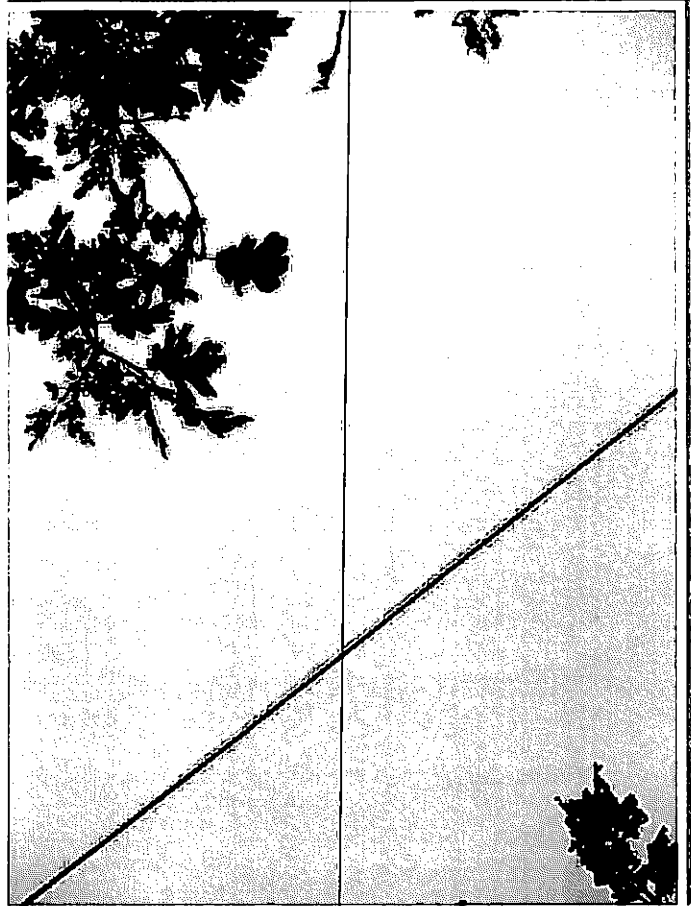
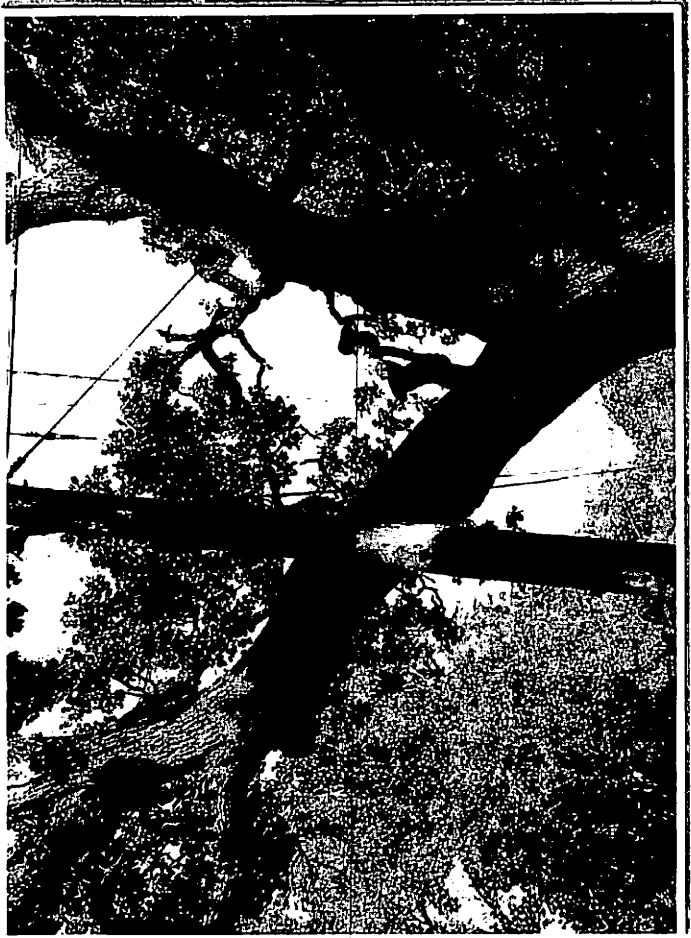
- To date, the Monitor team has not observed any specific trends or other issues unique to potential radial clearance exceptions.
- The example photo on the left shows vegetation observed within 4 feet of a conductor. The example photo on the right shows a tree that was pruned, but 12 feet of radial clearance was not achieved.

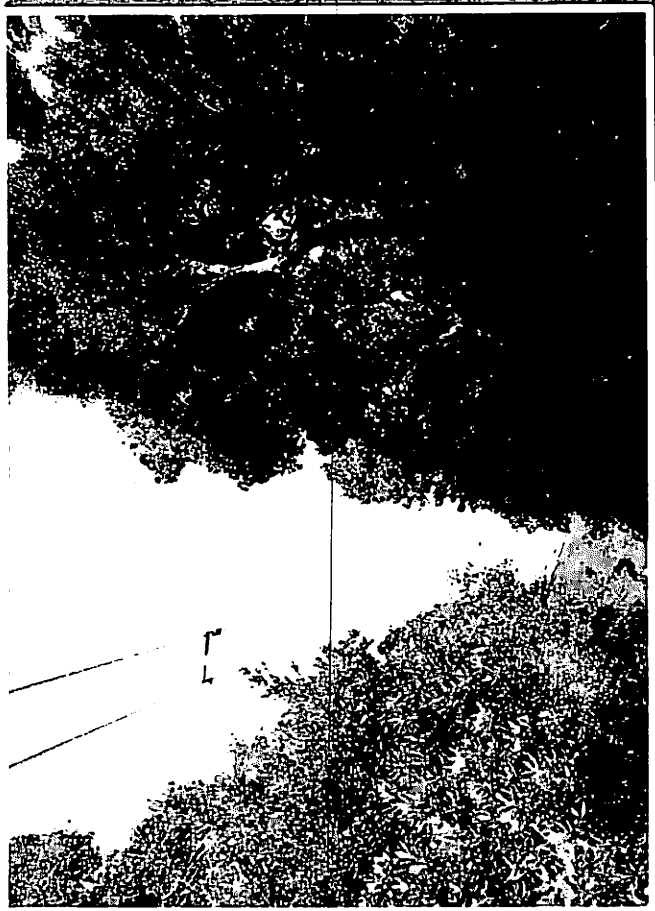
- An example of a hazard tree is shown below. Additionally, in some instances, potential hazard trees were marked with a yellow dot for pruning only (i.e., not removal), despite the fact that decay, rot, or other defects were observable in the area near the paint dot, and the overall health of the tree suggested that removal may have been the appropriate prescription.

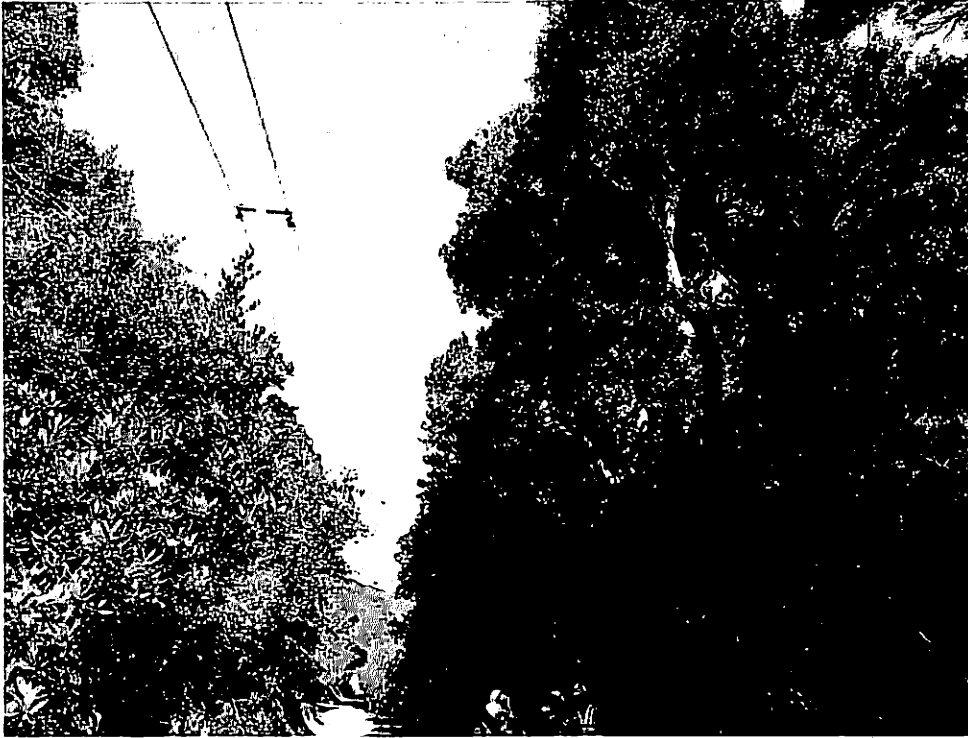
PG&E ArcCollector Project Status	Work Identified	
Monitor Team Observed Tree Work in Immediate Vicinity of Subject Tree	No	
Species	Coastal Live Oak	
GPS Coordinates	37.843595, -121.832268	
Approx. Distance from Primary Conductor	30 feet to the northeast, measured to farthest point of potential contact	
Approx. Height	65 feet	
Veg Type	Potential Hazard Tree	
Comments	<ul style="list-style-type: none"> Monitor Arborist observations of the tree include (a) a rotten cavity in the trunk, and (b) rotten heartwood

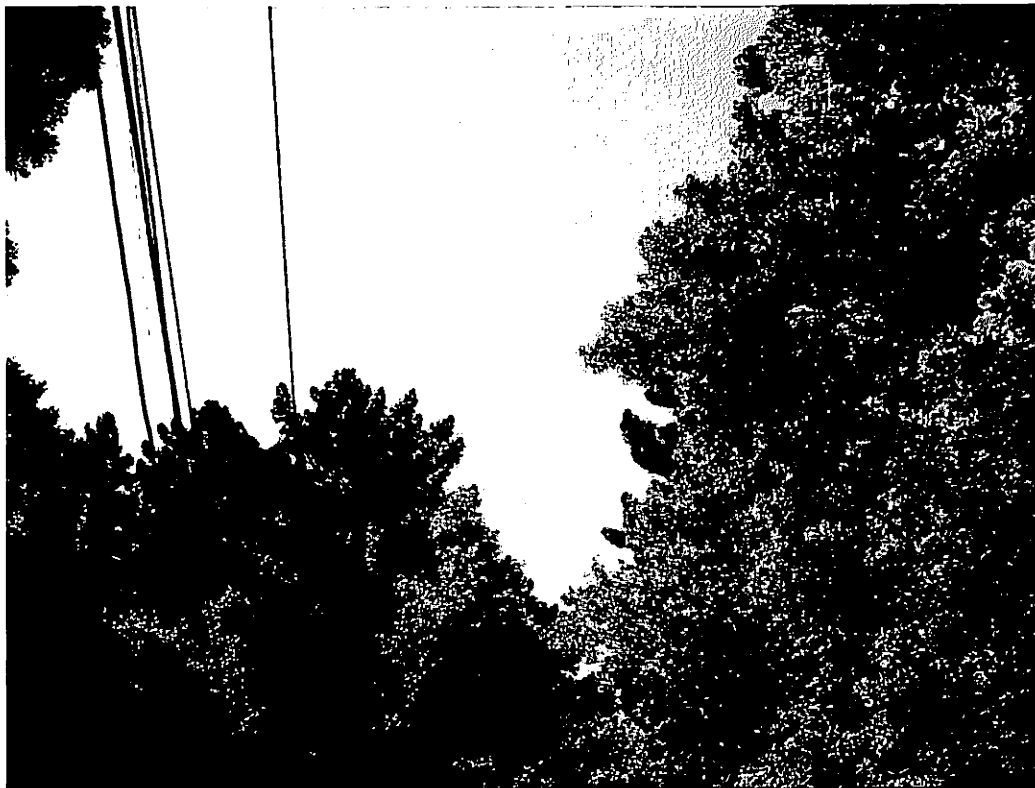
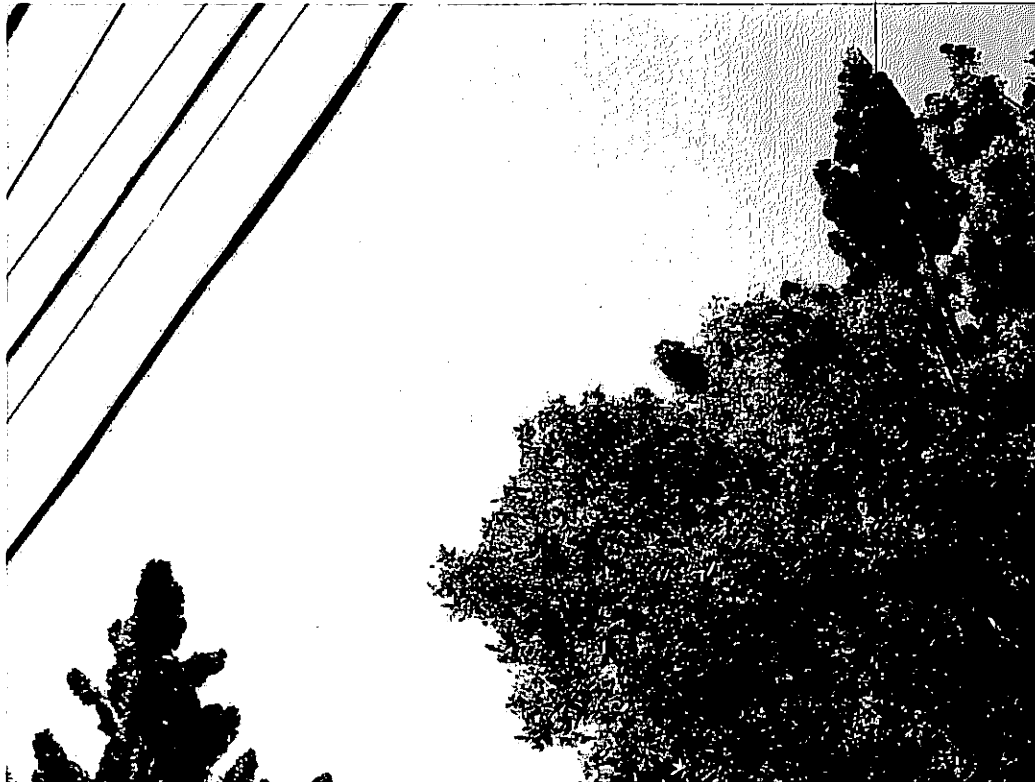
PG&E ArcCollector Project Status	Work Identified	
Monitor Team Observed Tree Work in Immediate Vicinity of Subject Tree	No	
Monitor Team Observed Recent Tree Work on Subject Tree	No	
Tree Paint or Other Markings Observed	No	
Species	Tan Oak	
GPS Coordinates	38.380156, -122.969689	
Approx. Distance from Primary Conductor	Trunk of tree 40 feet south	
Approx. Height	50 feet	
Veg Type	Potential Hazard Tree	
Monitor Arborist Comment	Observations of the tree include (a) trunk showing multiple cracks and signs of decay, (b) tree is leaning towards primary conductor, and (c) if tree fails, tree will contact primary conductor.

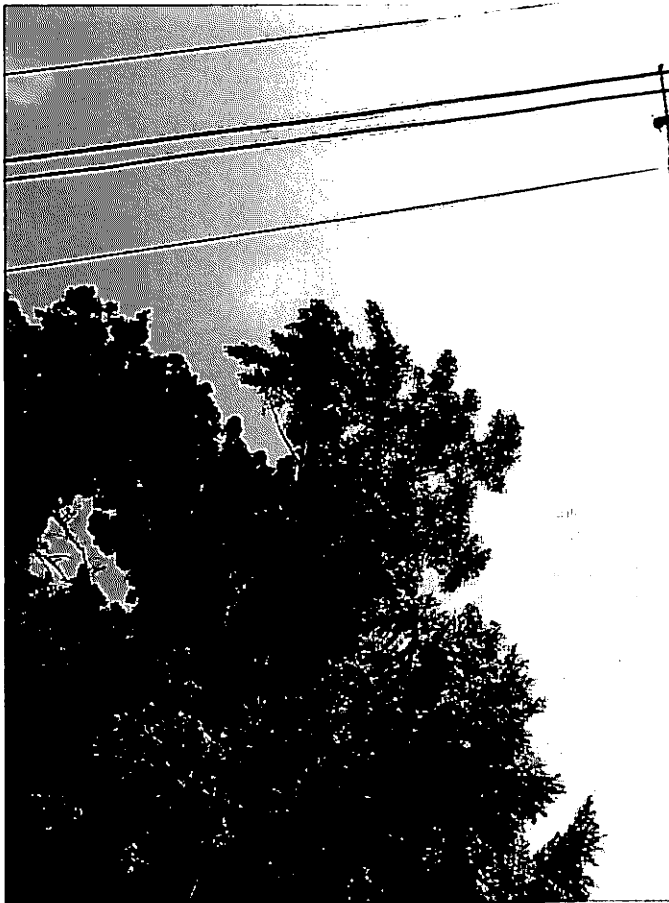
PG&E ArcCollector Project Status	Work Identified	
Monitor Team Observed Tree Work in Immediate Vicinity of Subject Tree	No	
Monitor Team Observed Recent Tree Work on Subject Tree	No	
Tree Paint or Other Markings Observed	No paint observed	
Species	Douglas Fir	
GPS Coordinates	38.4074348, -122.9278607	
Approx. Distance from Primary Conductor	Trunk of tree 50 feet southeast	
Approx. Height	100 feet	
Veg Type	Potential Hazard Tree	
Monitor Arborist Comment	Observations of the tree include (a) tree leaning 40 degrees towards the primary conductor, (b) failure would strike the primary conductor, and (c) no apparent lifting of the roots.

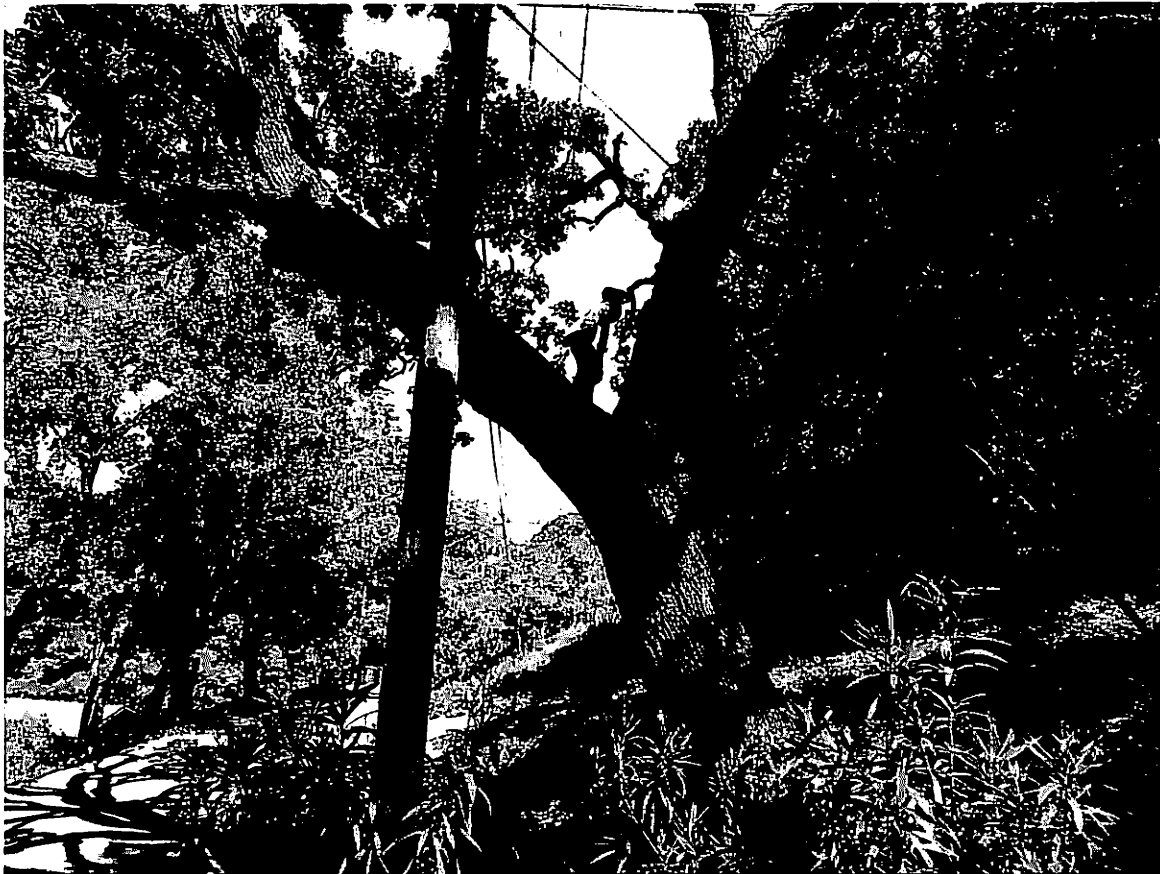
Photograph below shows subject tree and proximity to the primary conductor.
